**Flood Control Project Maintenance
Levee Inspections**

Fall 2011 Levee Maintenance Deficiency Summary Report

Sutter Maintenance Yard Maintenance Area 0007

Waterway			Bank	Unit Miles
Unit No. 01 Feather River			Right	12.07
	Spring (March - May)	Summer (June - August)	(September - November) Fall	Winter (December - February)
Unit Maintenance Rating (Fall Only)			A	
Date of Inspection	4/19/2011 - 4/19/2011		10/12/2011 - 10/12/2011	
DWR Inspector	Clay Thomas		Clay Thomas	
Accompanied By	Jason Cooper		Jason Cooper

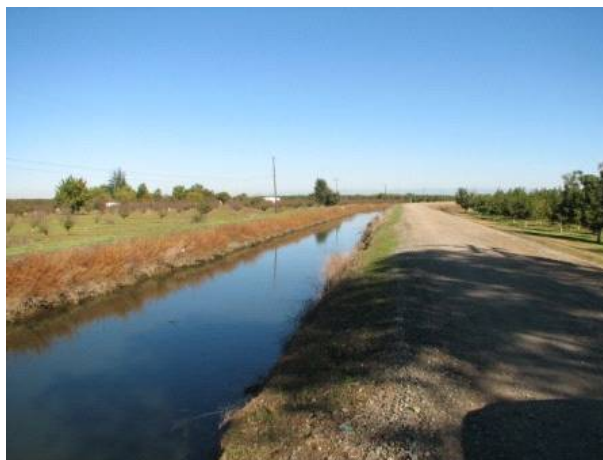
Levee Mile Report Line	1
Start Levee Mile	0.01
End Levee Mile	1.73
Location	Land Side
Category	Earthen Levee
Item	Encroachments

AG ditch landside slope and toe.

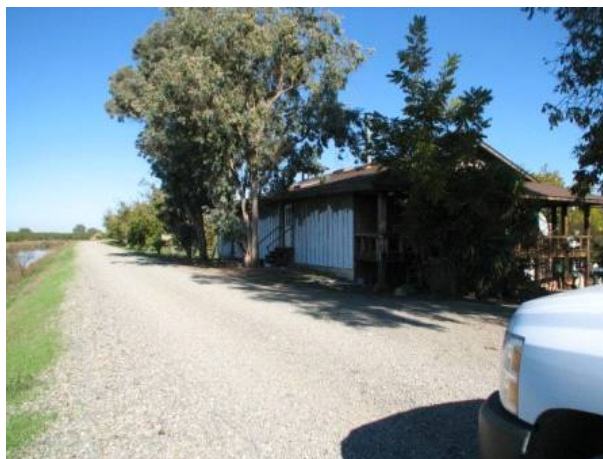
Levee Mile Report Line	2
Start Levee Mile	1.21
End Levee Mile	1.21
Location	Water Side
Category	Earthen Levee
Item	Encroachments

Levee mile 1.21. This is a photo of the building on the waterside slope.

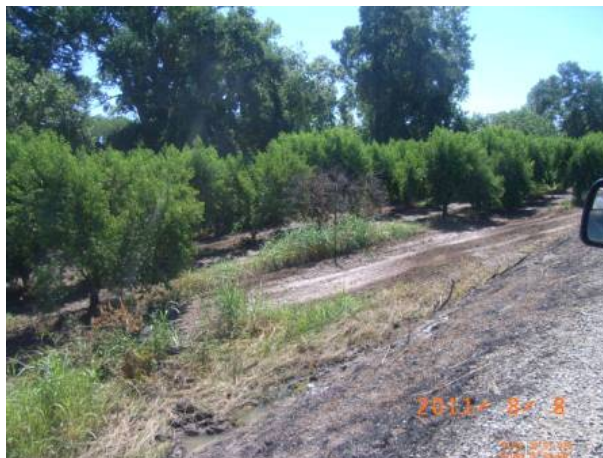
Levee Mile Report Line	3
Start Levee Mile	1.51
End Levee Mile	1.51
Location	Water Side
Category	Supplemental
Item	USACE Erosion Survey

USACE 2011 Photo #1

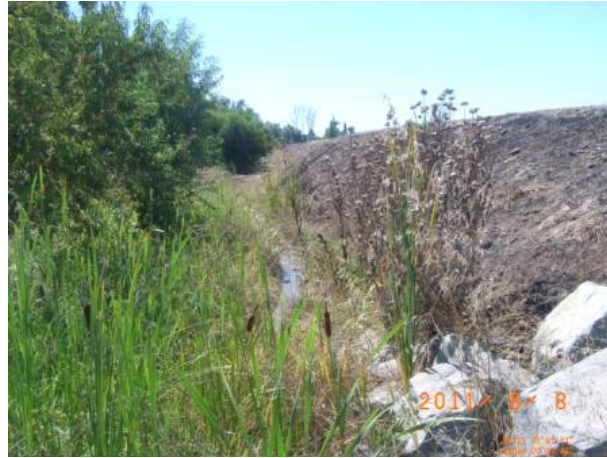
Levee Mile Report Line	3
Start Levee Mile	1.51
End Levee Mile	1.51
Location	Water Side
Category	Supplemental
Item	USACE Erosion Survey

USACE 2011 Photo #2

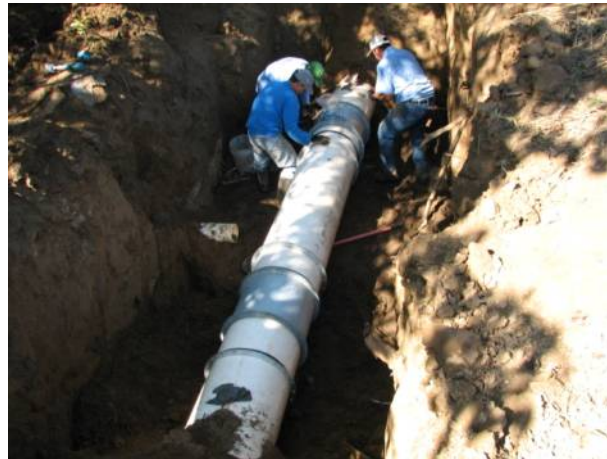
Levee Mile Report Line	5
Start Levee Mile	2.88
End Levee Mile	2.88
Location	Land Side
Category	Earthen Levee
Item	Encroachments

This photo shows a pipe approximately 24 inch in diameter at the landside toe of the levee, the pipe runs parallel with the levee, they are repairing the existing pipe.

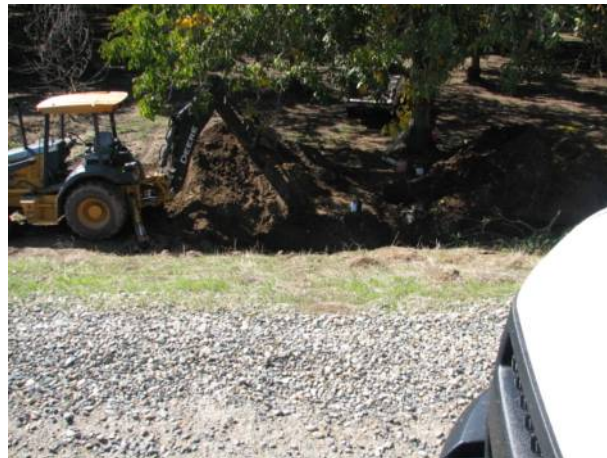
Levee Mile Report Line	5
Start Levee Mile	2.88
End Levee Mile	2.88
Location	Land Side
Category	Earthen Levee
Item	Encroachments

This is looking from the crown of the levee at the pipe repair site.

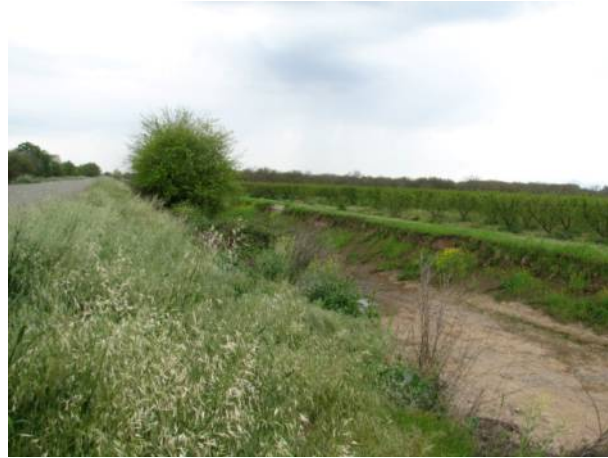
Levee Mile Report Line	7
Start Levee Mile	3.85
End Levee Mile	5.37
Location	Land Side
Category	Earthen Levee
Item	Encroachments

Levee mile 5.37. This is a photo of the AG ditch on the landside slope and toe.

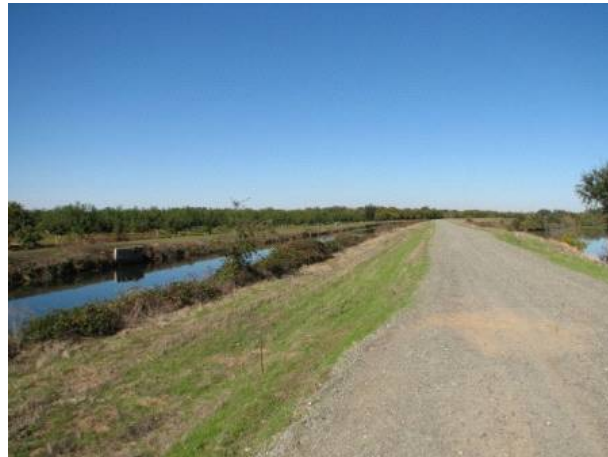
Levee Mile Report Line	7
Start Levee Mile	3.85
End Levee Mile	5.37
Location	Land Side
Category	Earthen Levee
Item	Encroachments

AG ditch landside slope and toe.

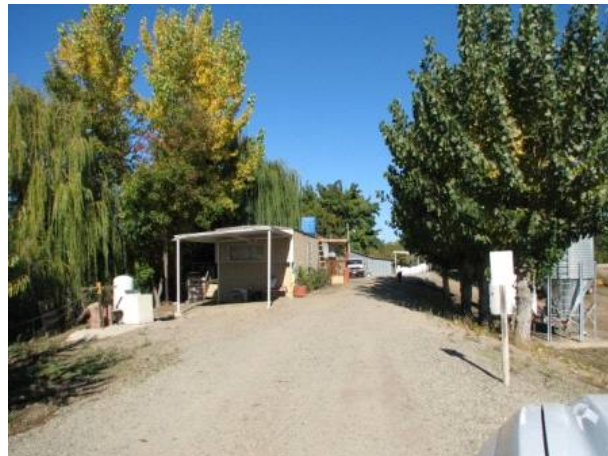
Levee Mile Report Line	11
Start Levee Mile	5.42
End Levee Mile	5.42
Location	Land Side
Category	Earthen Levee
Item	Encroachments

Levee mile 5.42. This photo shows a building on the landside crown, shoulder and slope.

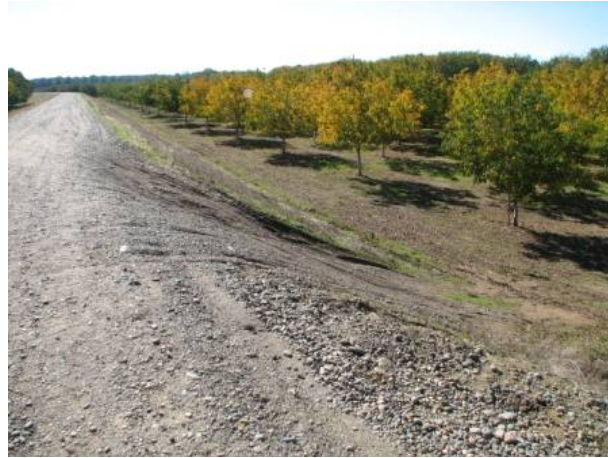
Levee Mile Report Line	15
Start Levee Mile	8.00
End Levee Mile	8.00
Location	Land Side
Category	Earthen Levee
Item	Erosion / Bank Caving

Levee mile 8.00. This photo shows the erosion on the landside slope.

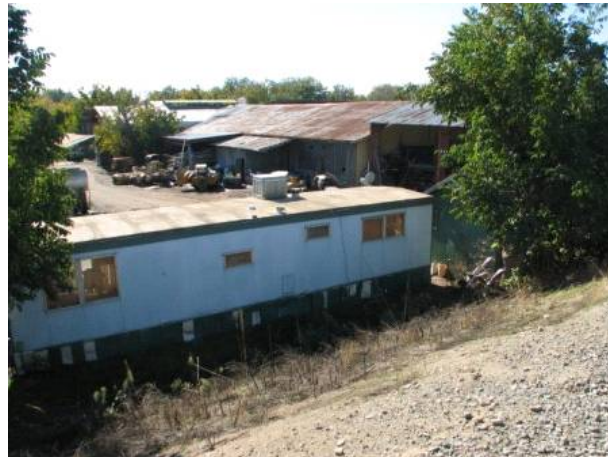
Levee Mile Report Line	19
Start Levee Mile	9.79
End Levee Mile	9.79
Location	Land Side
Category	Earthen Levee
Item	Encroachments

Levee mile 9.79. This photo shows a building at the landside toe.

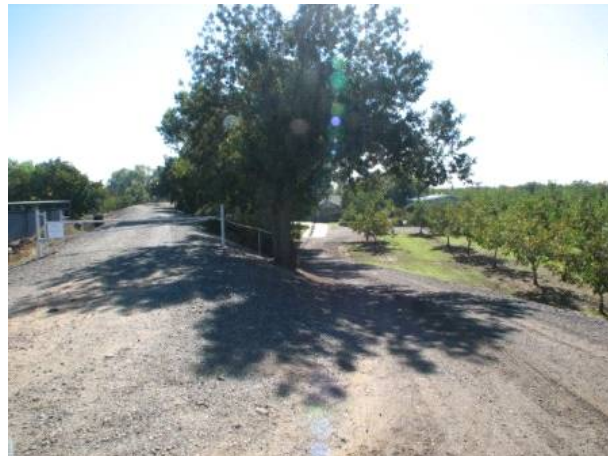
Levee Mile Report Line	23
Start Levee Mile	11.63
End Levee Mile	11.69
Location	Land Side
Category	Earthen Levee
Item	Encroachments

23	11.63	11.69	Earthen Levee	Encroachments	LS	PO	Landscaping	39.437119 ° -121.645860 °	39.437949 ° -121.646280 °	43 Y

Landside landscaping levee mile 11.63.
